Manhole Inspection Summary

Manhole # S55A__012MH

Record Plat: **55A** Node: **012** Status: **Found**

Insp Date: **6/24/08 9:59 AM**

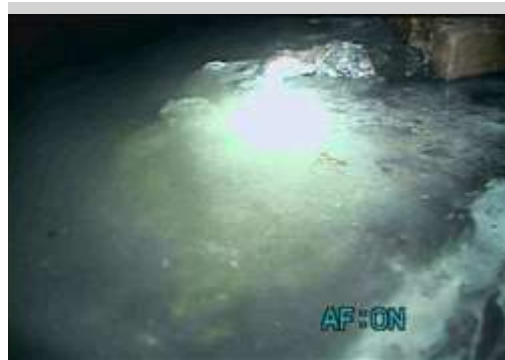
misc

another view of crack

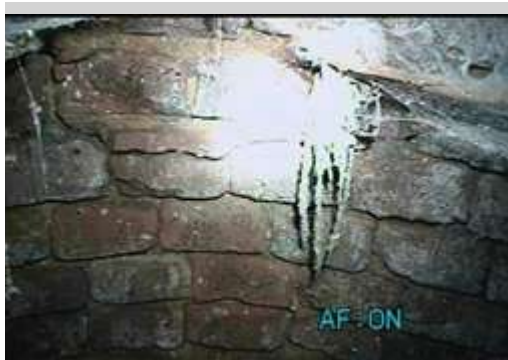
Defect 6

channel debris

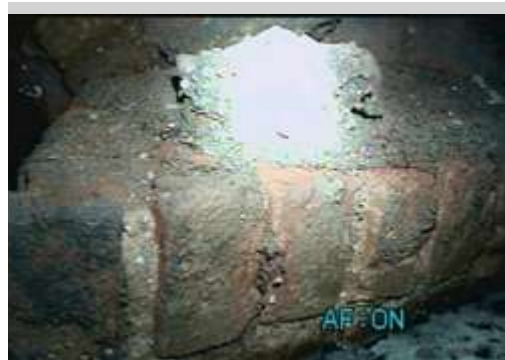
Defect 5

☒ **Evidence Of Surcharge** Depth: **3.** (ft.) ☐ Active Surcharge Present

surcharge

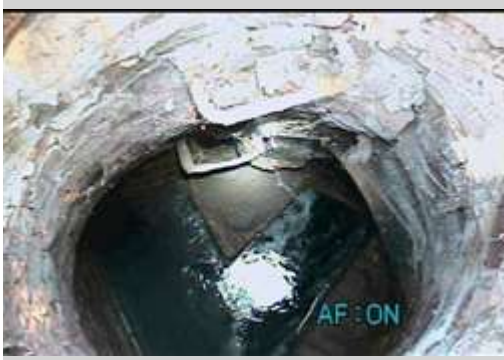
Defect 4

Condition: ☐ Sound ☒ **Cracked** ☐ Root Intrusion ☐ Deteriorated ☐ Leaks ☐ Debris

bench cracked

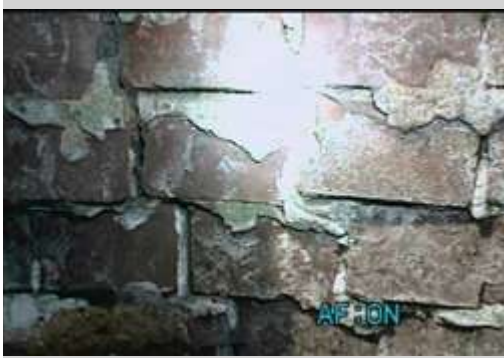
Defect 2

Condition: ☐ Sound ☒ **Cracked** ☐ Root Intrusion ☐ Loose Brick ☐ Deteriorated

fracture in barrel

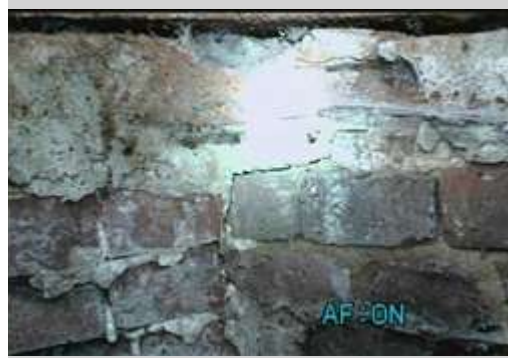
Defect 1

Condition: ☐ Sound ☒ **Cracked** ☐ Root Intrusion ☒ **Loose Brick** ☐ Deteriorated

crack in corbel, loose bricks

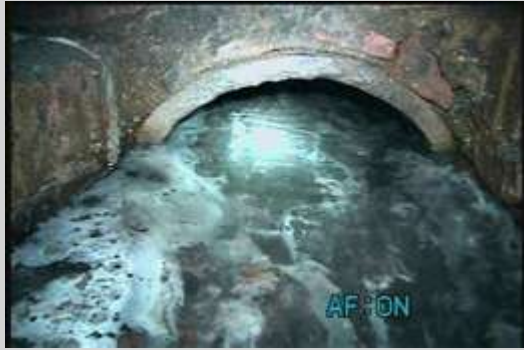
9 O'Clock Inflow

Deposits: ☐ None ☐ Mud ☐ Sludge ☒ **Debris** ☐ Grease

Silt Depth: **6** (in.) Deposits Extent: **Heavy**
